NASA Technical Memorandum 84909

Preliminary Experience With a Stereoscopic Video System in a Remotely Piloted Aircraft Application

Terrence W. Rezek

September 1983

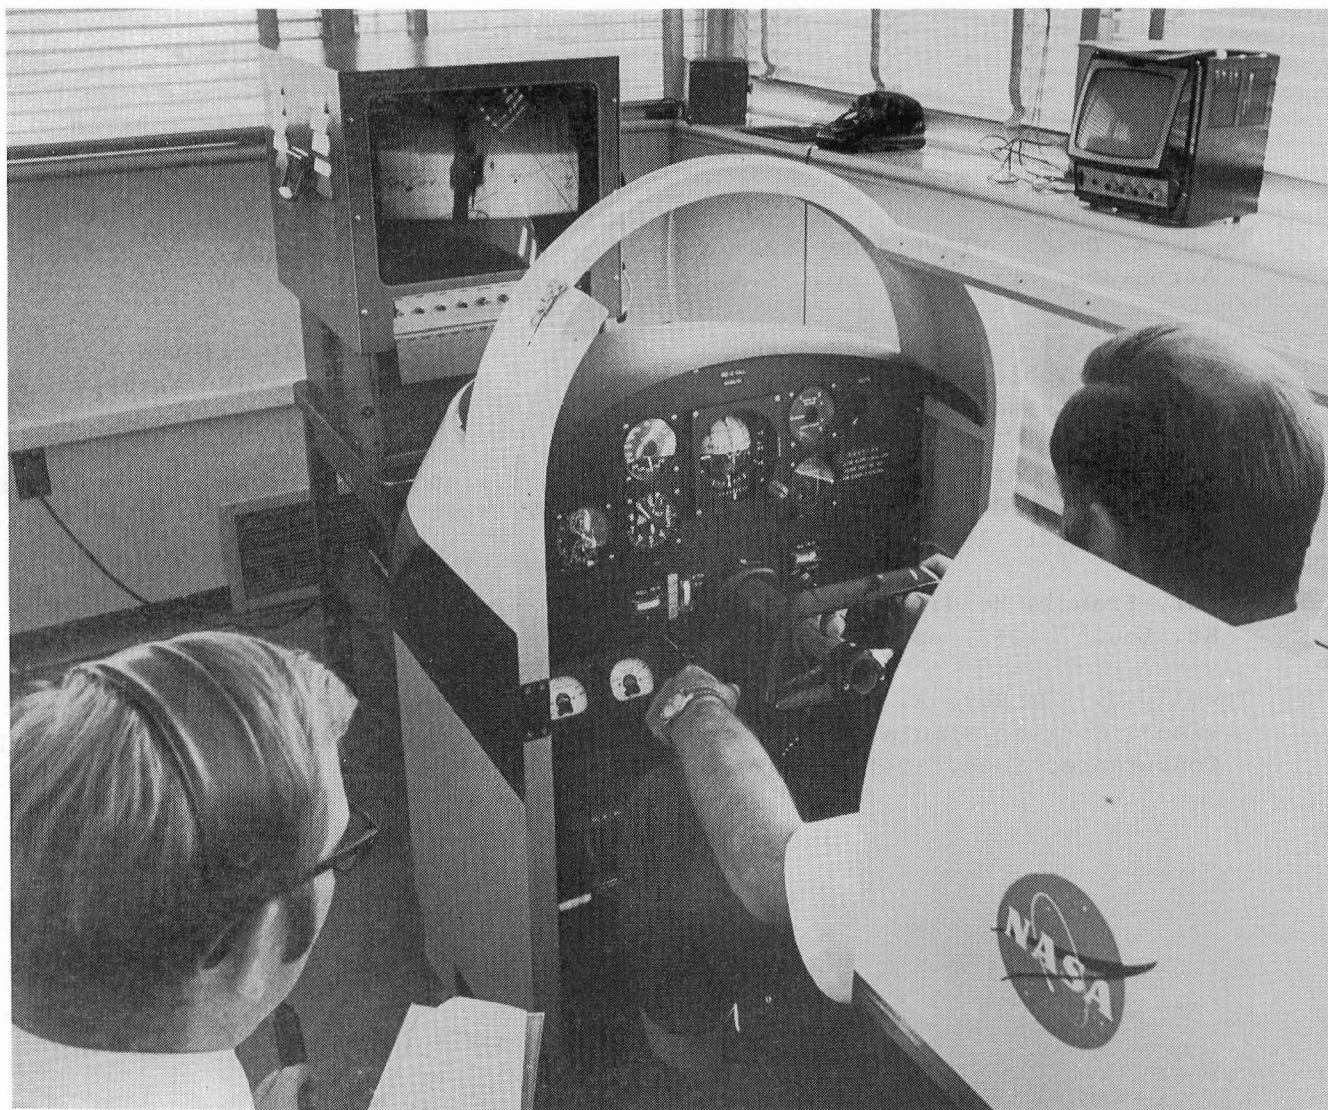
Figure 1. RPEX, the first RPV cockpit at Dryden. Note the video shows the ground plot board. There was no out-the-window video for these early flights.

Prior to 1969, flight-stress physiology studies at the NASA Dryden Flight Research Center had shown that elevated heart rates were associated consistently with mission responsibility. This addition occurred whether the pilot was in the aircraft flying, or just riding, or was on the ground acting as mission controller, even though physical conditions in each case were undemanding (ref. 1). This was not necessarily true in a simulator. Even when the pilot was overloaded with tasks and with personal performance gains at an apparent maximum, his heart rate never reached the levels seen in similar live flights. RPVs were seen as a way to resolve the question of personal concern being the operant factor in elevated heart rates during flight. Consequently, a primitive RPV system was built (fig. 1), utilizing a cockpit that was designed in-house, commercially available avionics and telemetry, and DFRC's Piper Twin Comanche aircraft (fig. 2).
